## Fuel Containment of Auxiliary Fuel Tanks

DOT/FAA/CT-TN94/17

U.S. Department of Transportation  
Federal Aviation Administration

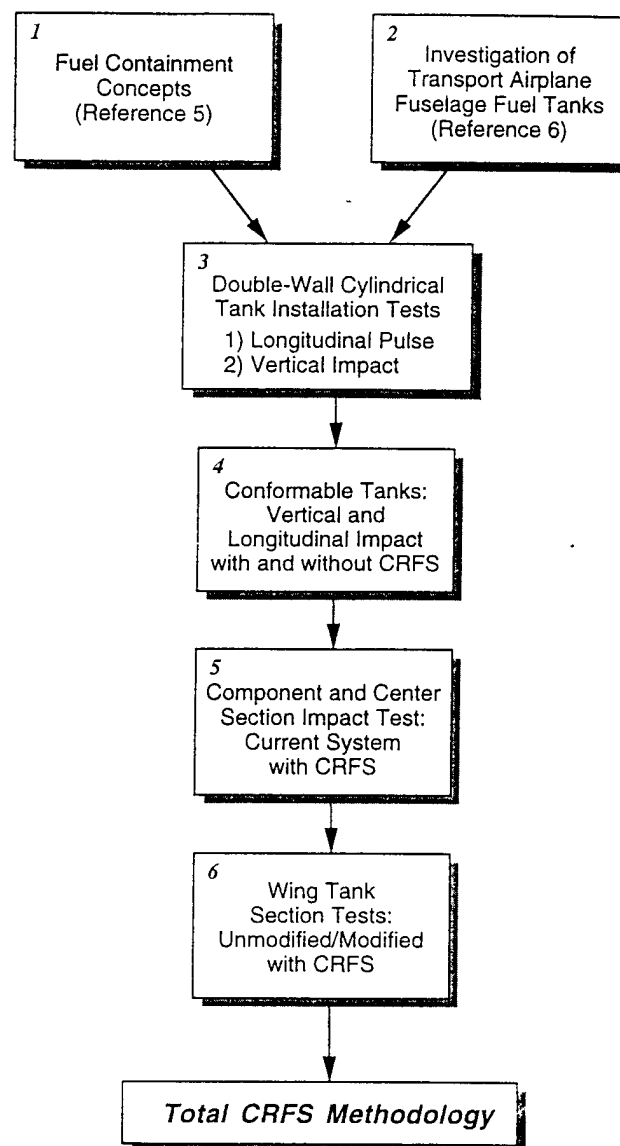
FIGURE 1. PROPOSED FUEL TANK INSTALLATION TEST PROGRAM

The three major domestic transport airplane manufacturers under contracts to the Federal Aviation Administration (FAA) and the National Aeronautics and Space Administration (NASA) (references 1-3) performed a comprehensive evaluation of FAR 25 airplane accidents from 1960-1979. Postcrash fires were noted as a major area of concern. The results of the Controlled Impact Demonstration (CID) crash test in 1985 (reference 4) suggested that alternatives to fuel additives for reducing or eliminating postcrash fire fatalities or injuries should be considered. The FAA initiated a program to investigate fuel containment concepts. Figure 1 illustrates the overall program as it was initially proposed.

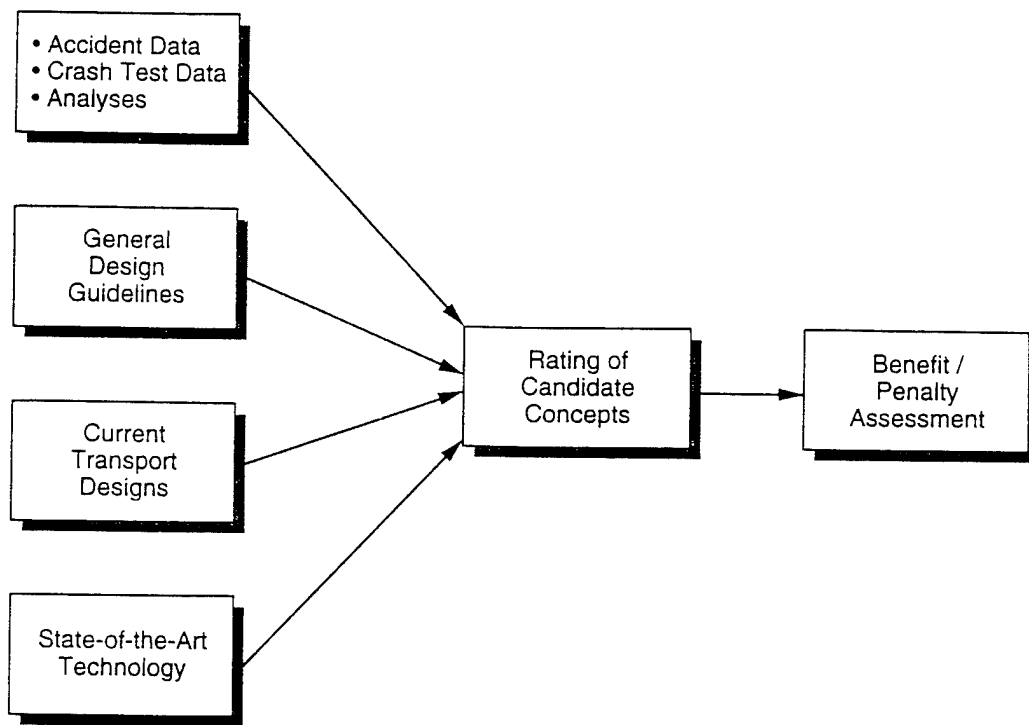
FIGURE 2. TRANSPORT CATEGORY AIRPLANE FUEL CONTAINMENT CONCEPTS

The tasks previously completed, before this current effort, are described in references 5-7. The flow diagrams for the initial “fuel containment concepts” and the subsequent “investigation of installations under crash loads,” are shown in figures 2 and 3. The most recent task (reference 7) included a longitudinal-pulse test of a fuselage section with a double-walled floor-mounted cylindrical auxiliary fuel tank. The FAA sponsored research also includes a vertical impact test of the same fuselage section with the same double-walled auxiliary fuel tank installed (reference 8). This latter test also included overhead bins and seats as well as the double-wall cylindrical auxiliary fuel tank, which is being evaluated by the FAA, research with regard to auxiliary fuselage fuel tank installations performance under crash impact conditions is ongoing. The objectives of the current effort described herein, is as follows:

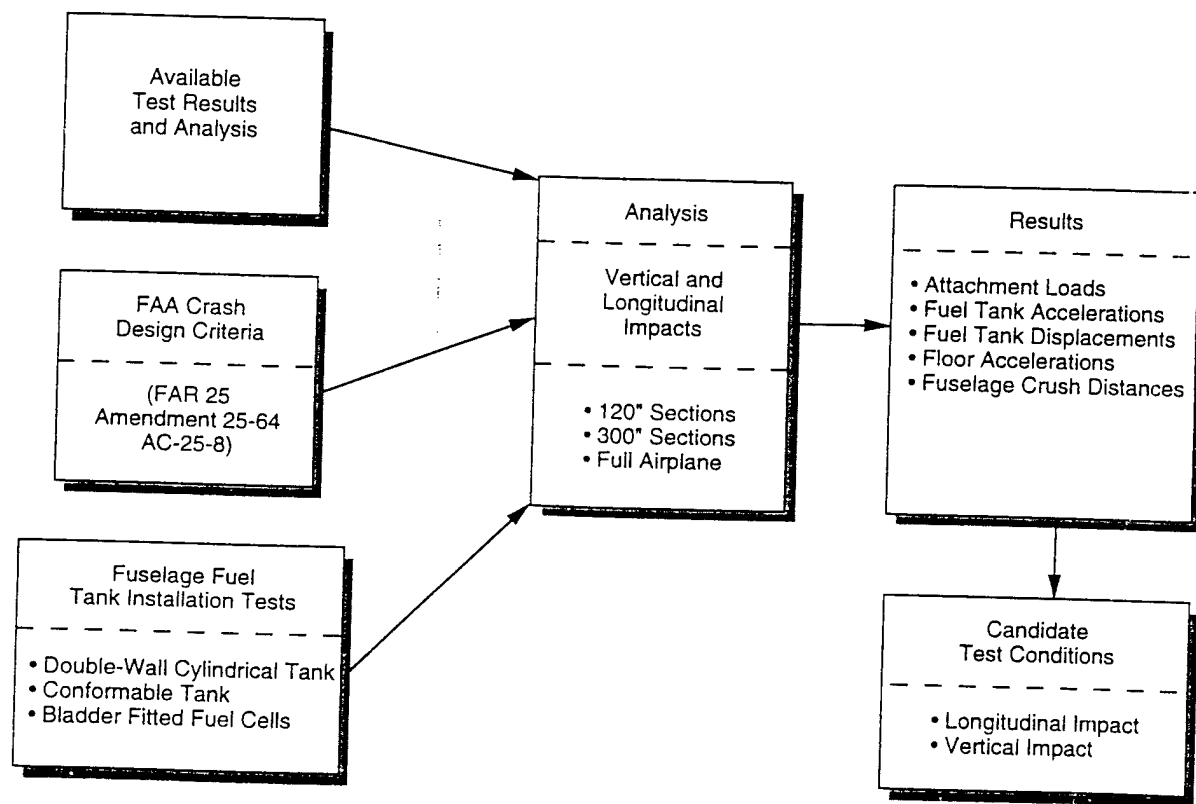
FIGURE 3. INVESTIGATION OF TRANSPORT AIRPLANE FUSELAGE FUEL TANK INSTALLATIONS UNDER CRASH CONDITIONS

- a. A review of the double-wall auxiliary fuel tank longitudinal test (as it pertains to conformable tanks).
- b. A review of the Auxiliary Fuel System Installation Advisory Circular.
- c. Review of available recent pertinent transport category accidents and full-scale crash test results.
- d. An assessment of and determination of a fuel tank/airframe installation for the next longitudinal and vertical impact test.
- e. The outline of a procedure to be used to evaluate fuselage auxiliary fuel tank installation performance under dynamic loading using available and pending test data.

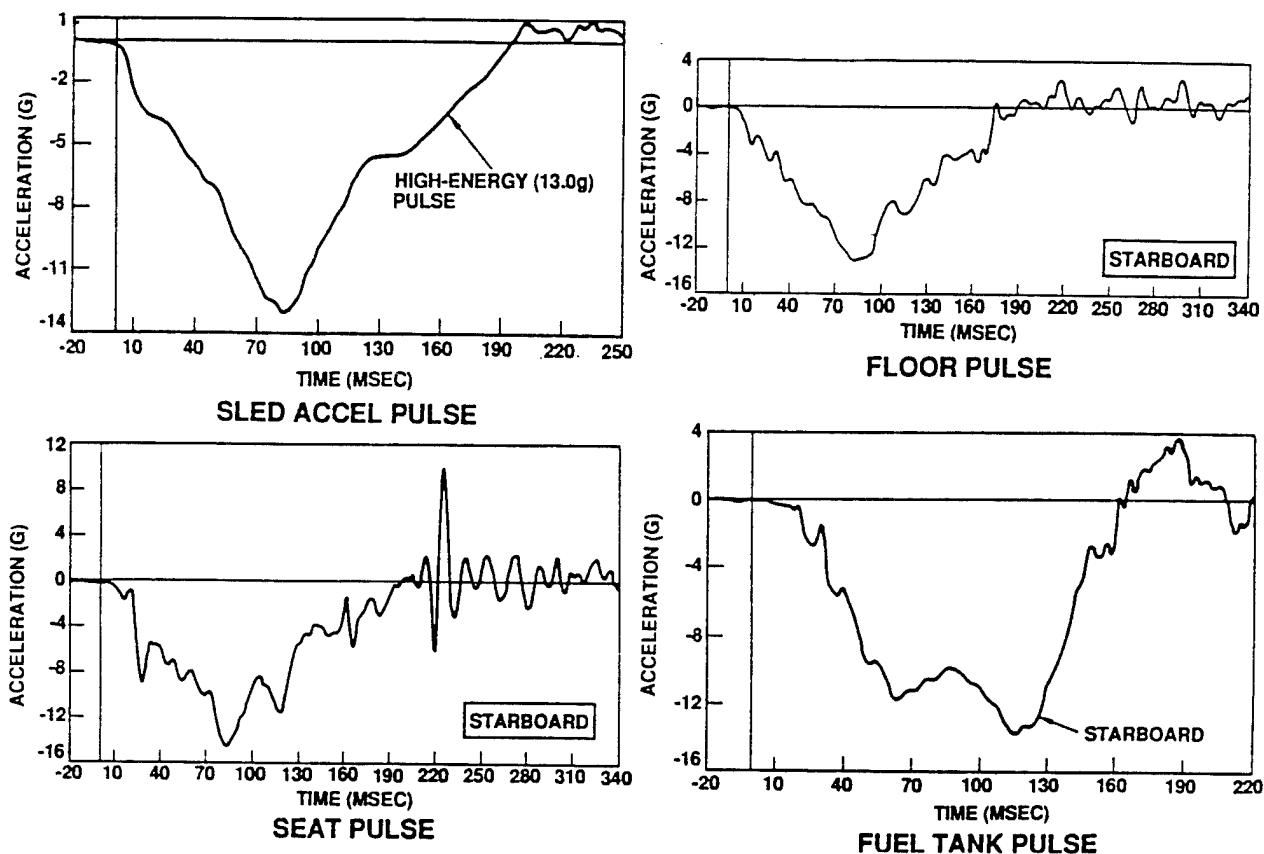
FIGURE 4. AUXILIARY FUEL TANK TEST LONGITUDINAL DIRECTION PULSES

b. During the high-energy dynamic pulse test, the sled acceleration was 13.0 g's. The average of four floor accelerometers was 13.7 g's (12.9, 13.1, 13.1 and 15.0 g's) and the two fuel tank accelerometers recorded 13.7 g's and 14.0 g's. Thus, the dynamic amplification factor can be considered between 1.054 and 1.076. The two lower energy pulse tests produced amplification factors of 1.08 or less. The responses at the high energy test conditions are shown in figure 4.

c. The high-energy test provides a sled pulse which is close to symmetrical. The rise time to the peak g occurs at 0.084 second. The velocity change of 38.6 ft/s indicates a total pulse duration of 0.185 second.

d. The dynamic amplification of a single degree of freedom depends on the system natural frequency and damping, the pulse rise time, and the pulse shape. For a symmetrical

triangular pulse exhibiting a 0.084 second rise time and highly damped system (0.25 critically damped) with a natural frequency of 9.2 Hz, an amplification factor of 1.08 is reasonable.

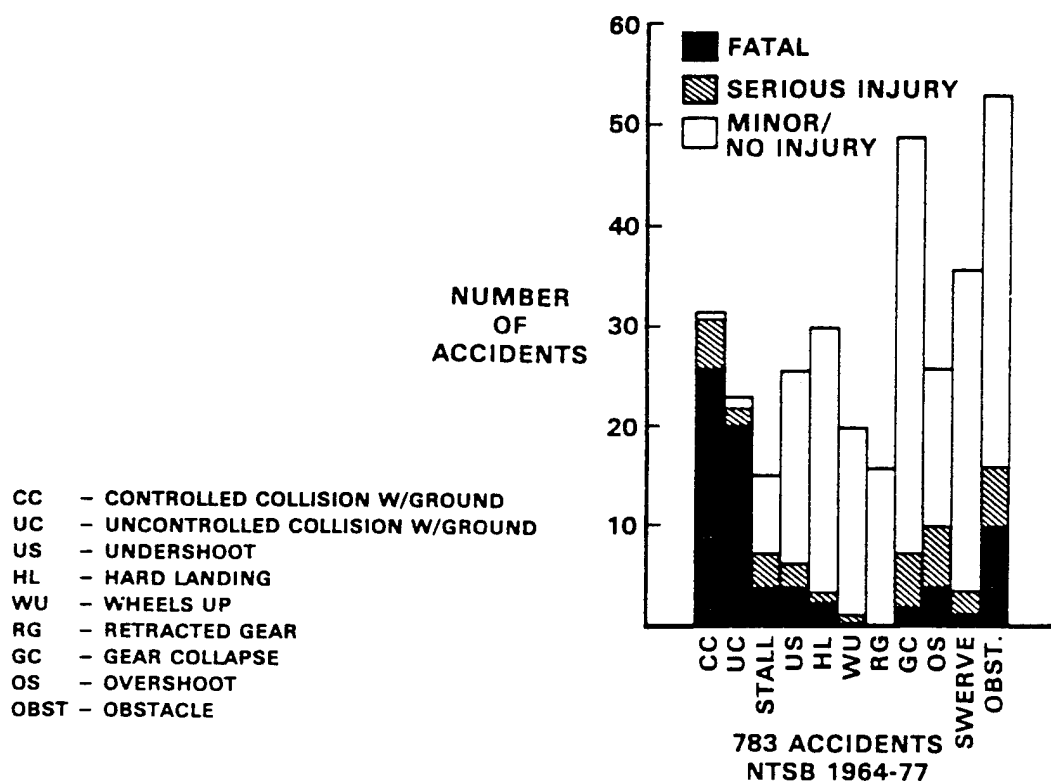
FIGURE 5. INJURY SEVERITY AS A FUNCTION OF ACCIDENT TYPE

The review of the Auxiliary Fuel System Installations AC 25-8 clearly indicates that there is a discrepancy between the static load factors that the guidelines address and the dynamic loads associated with the impact conditions that exist for severe, but survivable crashes. Figure 5

(reference 1) shows that there is a wide range of accident conditions that confront a transport category airplane. Some accidents, such as the air-ground collisions, both controlled and uncontrolled, are most likely outside the realm of practical design considerations. Others, such as wheels-up and retracted gear landings are minor crashes because of the lack of serious injuries or fatalities that are experienced. It is these types of accidents that the AC 25-8 appears to address. However, there are several accident types that are more representative of the impact conditions where fuselage auxiliary fuel tank installations should maintain sufficient structural integrity for passenger safety. These types of accidents; i.e., undershoot landing, hard landing, gear collapse, overshoot, and impact with obstacles, can be identified by two broad crash scenarios, ground-to-ground and air-to-ground. Characteristics of impact parameters for a ground-to-ground scenario are

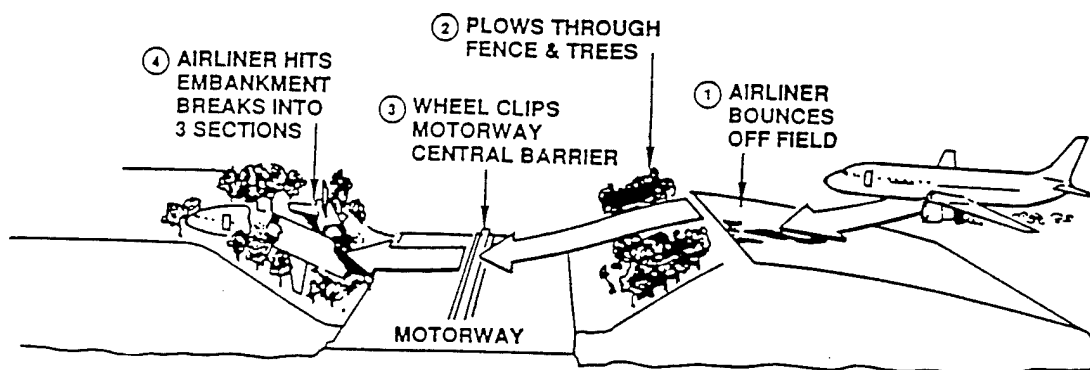
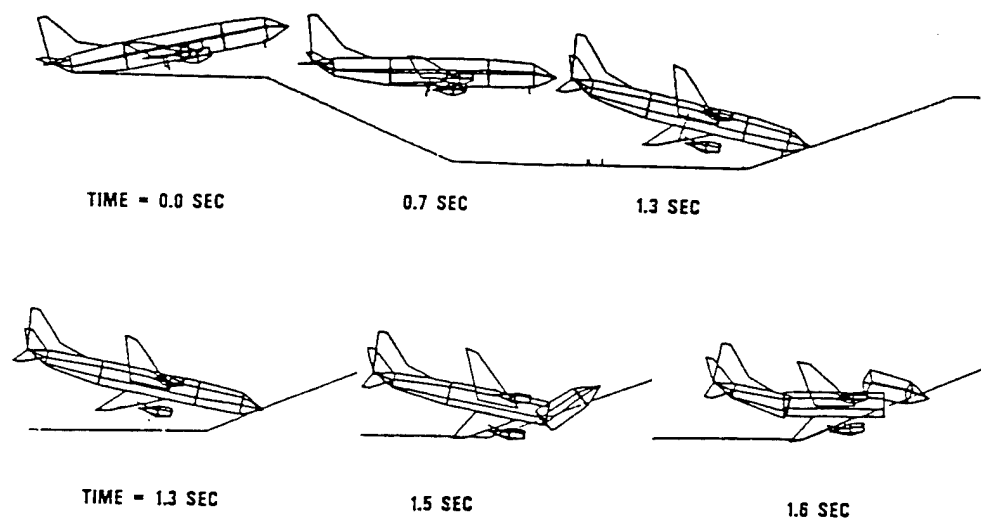
FIGURE 6. KEGWORTH ACCIDENT SCENARIO

Pitch attitude	=	4.5 degrees nose up
Roll attitude	=	24.0 degrees right wing down
Yaw attitude	=	13.0 degrees nose right
Flight path velocity	=	163.5 ft/s
Flight path	=	11.0 degrees
Descent rate	=	31.7 ft/s
Terrain	=	5.0 degrees downward slope

e. Damage consisted of

1. two major fuselage breaks; (1) between body stations 560 and 579 and (2) between body stations 984 and 1117;
2. separation of both main landing gear;
3. extensive damage to the right wing: separated at stub;
4. impact damage to left wing: fuel tanks intact; and
5. several seats damaged: various types.

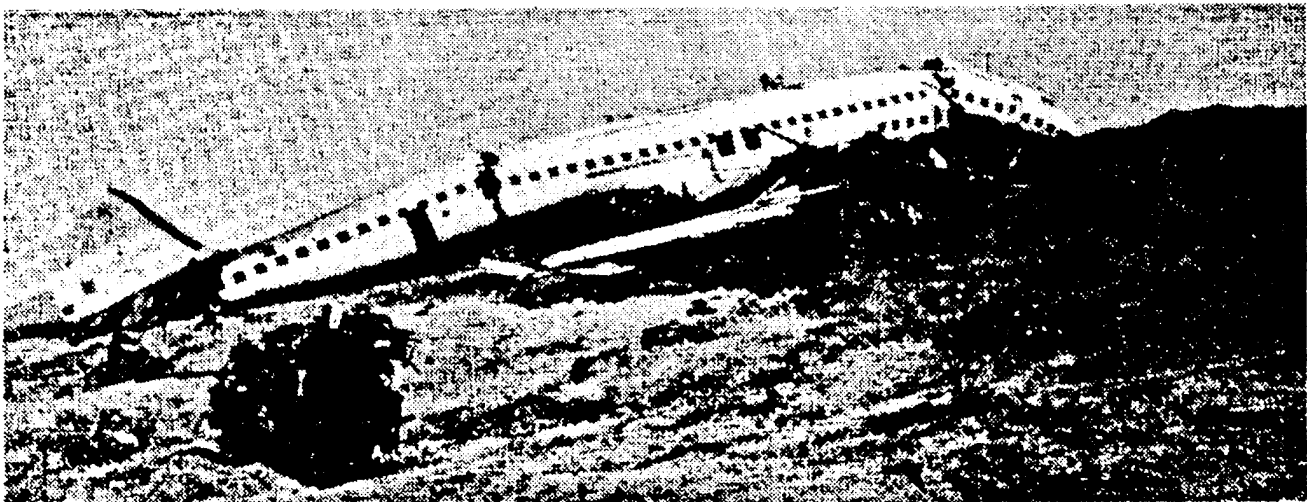
FIGURE 8. CRASH TEST: IMPACT DAMAGE

The initial slope impact occurred with an airplane forward velocity of 172 ft/s. This produced an effective sink speed normal velocity (ENV) of 18.5 ft/s. This was not sufficiently severe to produce a fuselage break. The impact onto the second slope (20-degree) at a forward velocity of 103 ft/s produced an ENV of 37.5 ft/s. This latter impact was severe enough that the airplane experienced two fuselage breaks, one aft of the nose section and the other near the wing trailing edge, as shown in figure 8. Besides the loss of all the gears upon barrier impact, there was extensive wing damage and loss of simulated fuel in the wing tanks due to pole and mound impact. During the severe impact onto the 20-degree slope (figure 8) the forward nose section recorded the following:

- a. longitudinal: 20 g's, 0.012-second duration, trapezoidal pulse, and
- b. vertical: 40 g's, 0.060-second duration, triangular pulse (20 g's fundamental pulse).

The mid-fuselage section floor experienced pulses such as 10 g's peak and 0.020 second duration.

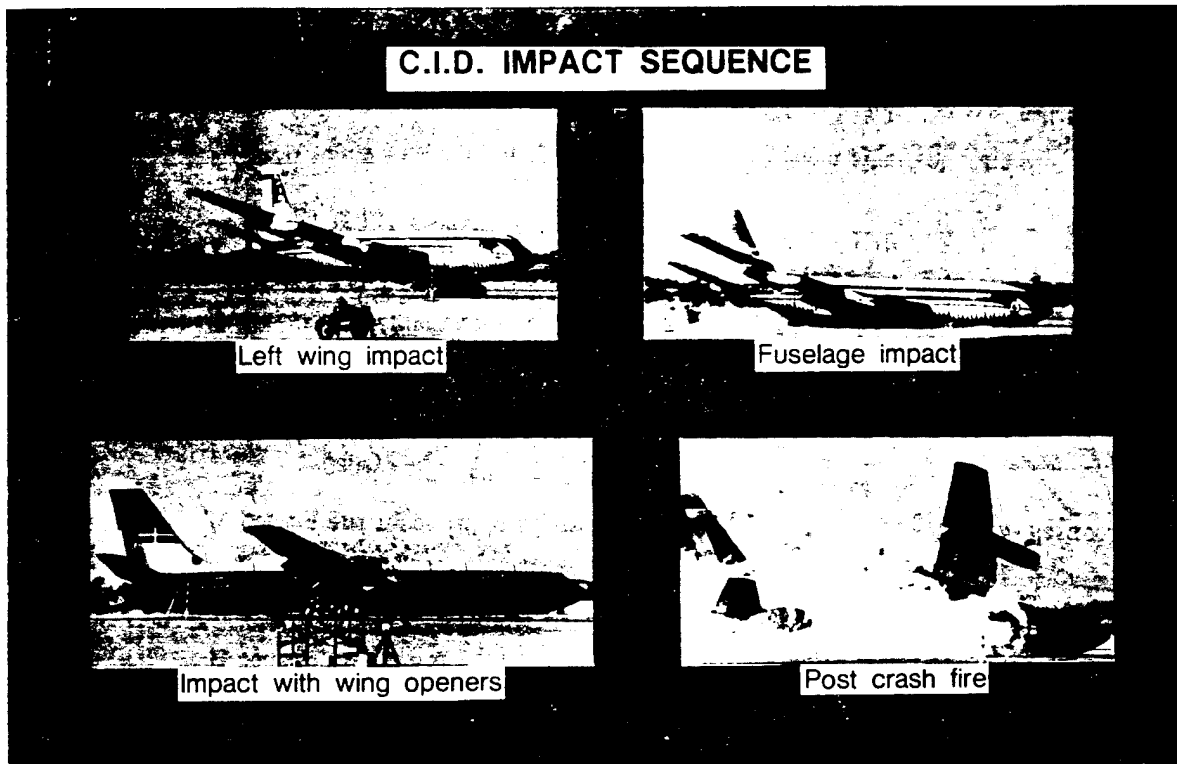
FIGURE 9. CID FULL-SCALE CRASH TEST SCENARIO

In this crash scenario (figure 9), the impact conditions were as follows:

The airplane impacted first on the left wing (No. 1) outboard engine, then the left wing (No. 2) inboard engine, and subsequently impacted on the forward fuselage. The forward fuselage impact was estimated to occur 400 ms after initial engine impact. The forward fuselage impact conditions were estimated to be 14 ft/s sink speed, 0 to 2 degrees nose down pitch attitude, and a forward velocity of 150 knots.

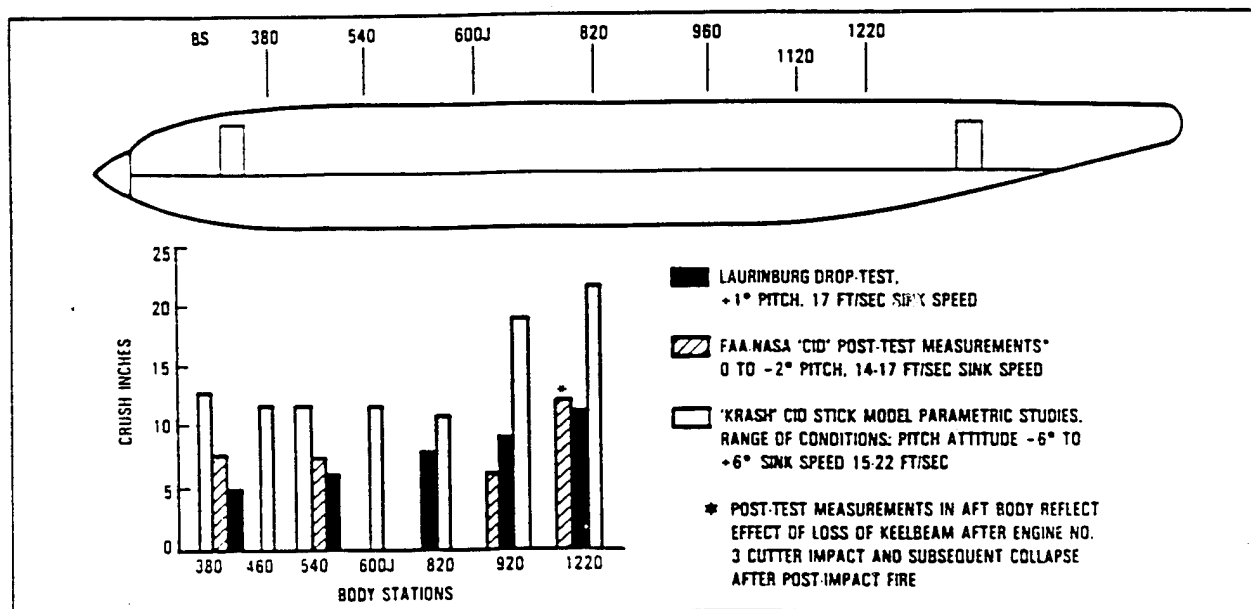
FIGURE 10. FUSELAGE CRUSH DISTRIBUTION

Before the CID full-scale crash test, the FAA conducted a drop test of a similar airplane at the same impact conditions, except with no forward velocity, roll, or yaw. This test (the "Laurinburg" drop test) was to evaluate the airframe strength and failure characteristics for an aircraft similar to the CID test article under comparable attitude and sink speed impact conditions. A B707-131 airplane, which is 100 inches longer (20 inches forward of BS 620 and 80 inches aft of BS 960) than the CID test article, but of the same construction and design was used for this test. The test results, with the KRASH analysis of this impact, revealed the distribution of fuselage crush that could be anticipated for the CID. The KRASH model was refined in the fuselage underside crush and overall fuselage strength characteristics' areas. The CID and Laurinburg tests provided hard data concerning fuselage underside crush distances that might be experienced in a moderate impact. After the CID test, parametric analyses were performed, and an envelope of fuselage crush distribution was developed as shown in figure 10.

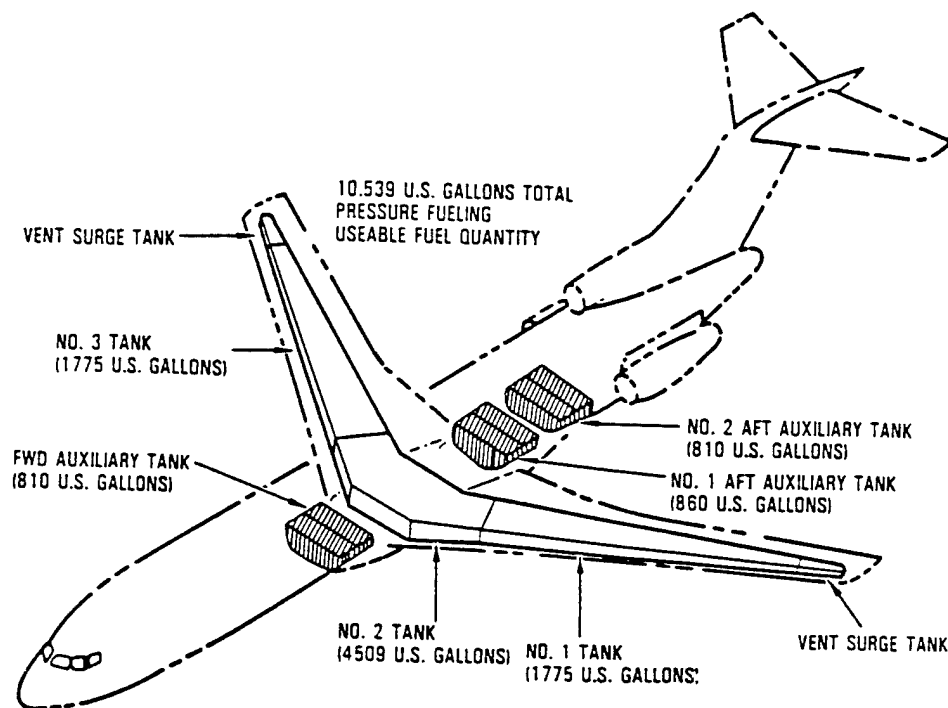
FIGURE 11. TYPICAL NARROW-BODY AIRPLANE CONFORMABLE AUXILIARY FUEL TANK INSTALLATION

Discussions were held with industry relative to obtaining fuselage mounted auxiliary fuel tanks. An industry source indicated that two sizes of conformable auxiliary fuel tanks are used in their B-727 and B-737 airplanes. The two sizes and their locations are (1) an 860-gallon tank installed in B-727 aft section, and (2) an 810-gallon tank installed in B-737 aft section or B-727 forward and aft sections. A typical fuel tank installation arrangement is shown in figure 11.

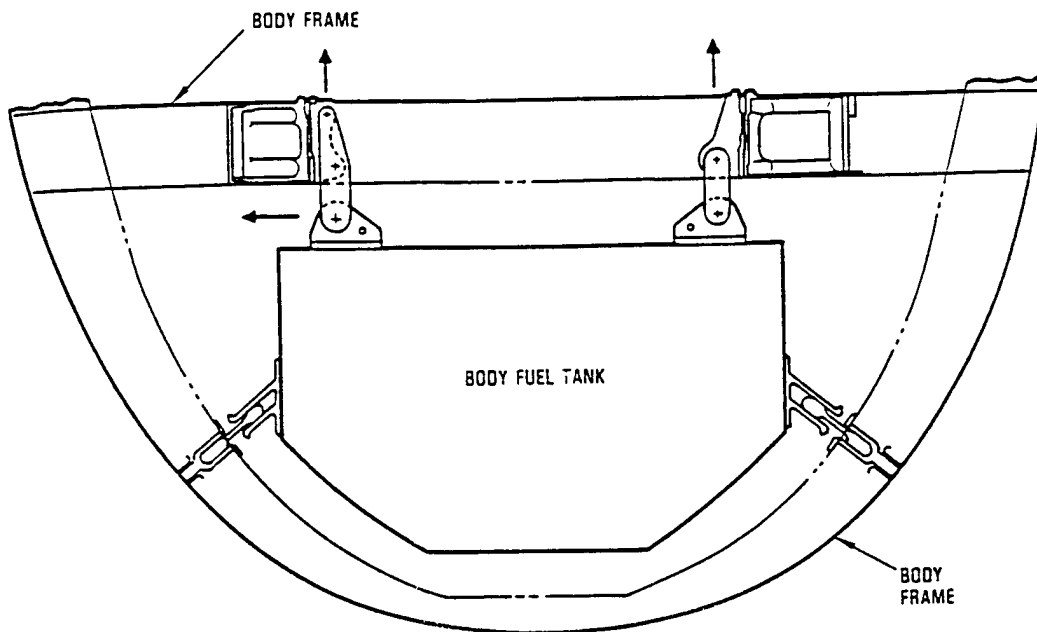
FIGURE 12. CONFORMABLE AUXILIARY FUEL TANK INSTALLATION ATTACHMENT LAYOUT

The particular tanks that fit the above-mentioned installations are attached to the fuselage and floor as shown in figures 12 and 13. After consideration of available tank and fuselage configurations, it was decided to use a 500-gallon conformable tank in a B-737 fuselage section.
